BEST PRACTICES FOR IMPLEMENTATION OF TACK COAT: PART 2, FIELD STUDY

Research Report ICT-12-005

A report of the findings of
ICT-R27-100
Best Practices for Implementation of Tack Coat

Illinois Center for Transportation

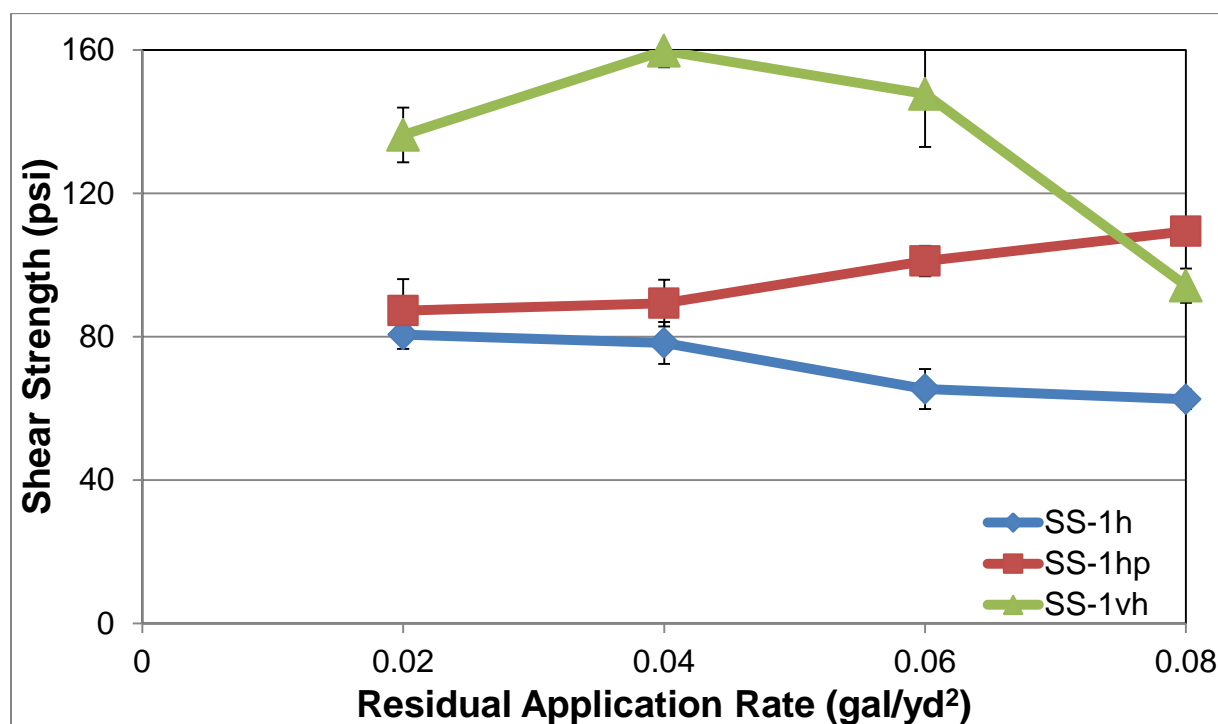
Figure 5.7. Shear strength for milled surfaces.

The optimum application rate was analyzed using only the conventional paving method. Three tack coat materials (SS-1h, SS-1hp and SS-1vh) were applied on top of milled HMA at four application rates (0.02, 0.04, 0.06 and 0.08 gal/yd²; 0.09, 0.18, 0.27 and 0.36 L/m²). As shown in Figure 5.7, a clear optimum can be observed for SS-1vh at an application rate of 0.04 gal/yd² (0.18 L/m²). However, for SS-1hp (and to a less extent SS-1h) there was no clear peak in the trend. During the construction of these particular sections, the two tack coat materials were applied a day in advance of paving due both to logistical issues and to follow a common practice in the state of Illinois. These sections were kept un-trafficked until the tack coat material was completely cured; however, they were open to traffic afterwards. This practice might have an effect on the results.

Selecting the correct tack coat for a particular project will improve its service life. As seen in Figure 5.7, SS-1vh had the best performance among the tack coat materials considered. This was observed throughout this study.

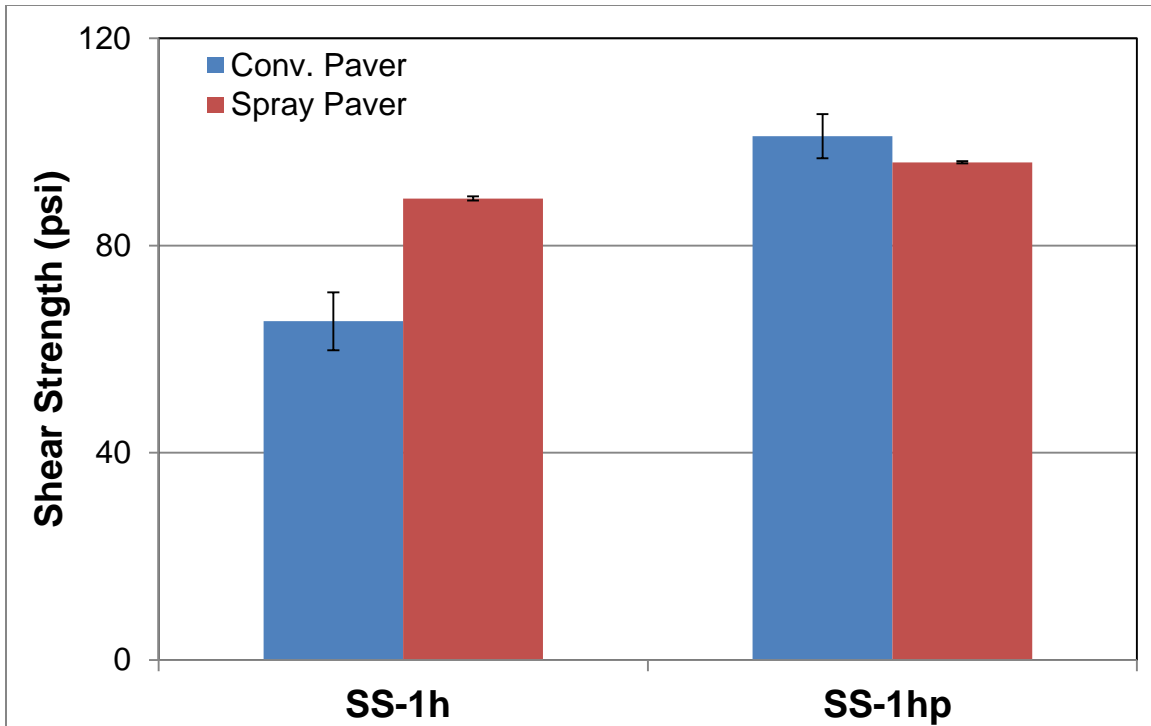
Figure 5.8. Shear strength for both paving methods used with broom cleaning.

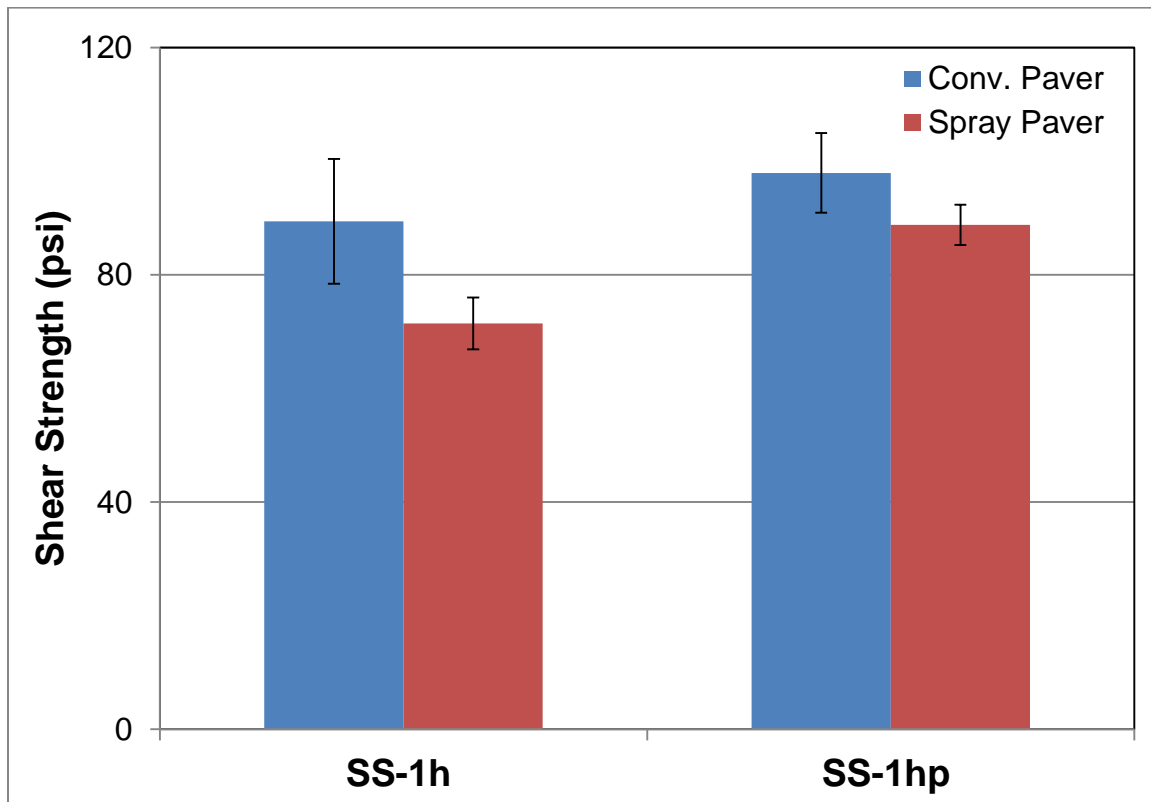
Figure 5.9. Shear strength for both paving methods used with the air-blast cleaning method.

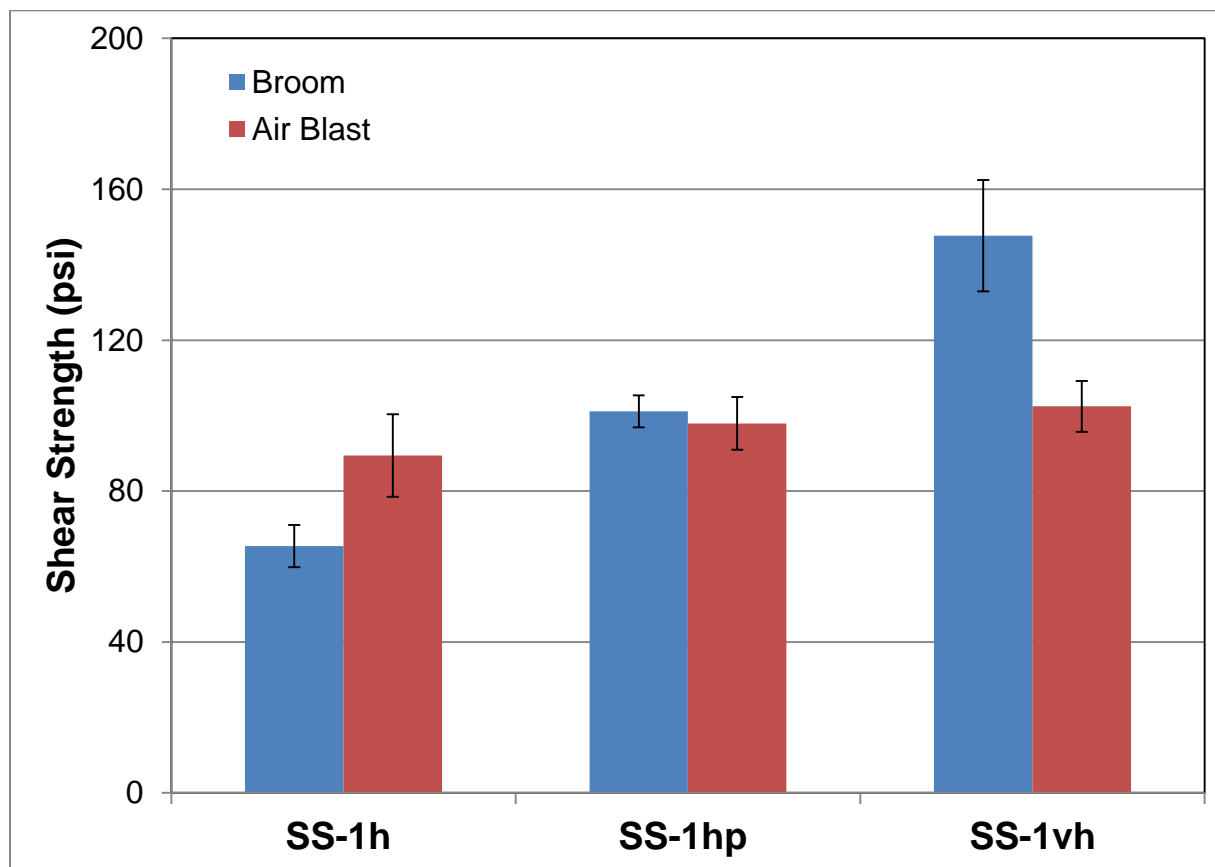
Figure 5.10. Shear strength for both cleaning methods using conventional paving practices.

As depicted in Figure 5.10, air-blast cleaning performs equally well or better with SS-1h and SS-1hp emulsions; however, a reduction in shear strength was observed when SS-1vh emulsion was used with a conventional paving method. This reduction could be because the optimum application rate for SS-1vh is 0.04 gal/yd² (0.18 L/m²) for this cleaning method. This was also seen on the I-80 project. Similar results were observed when the sprayer paver was used, as shown in Figure 5.11.

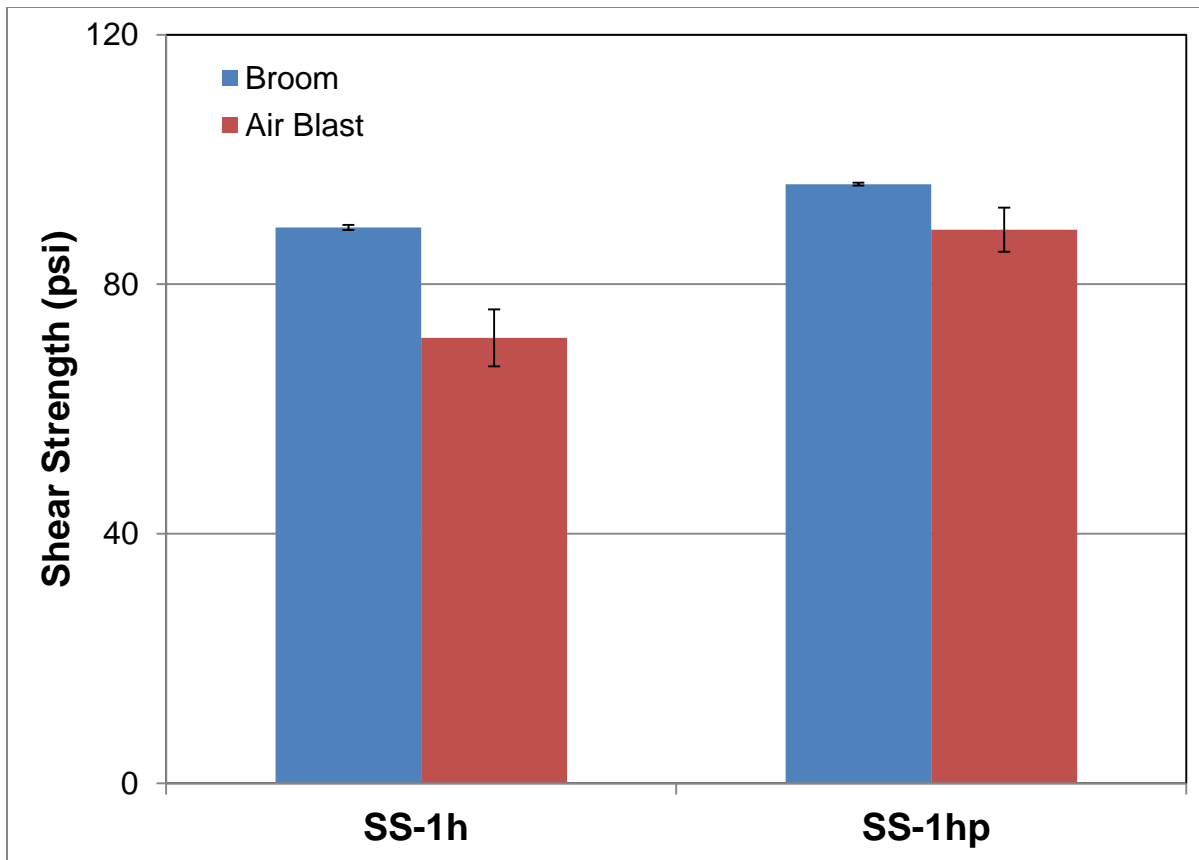
Figure 5.11. Shear strength for both cleaning methods using a spray paver.

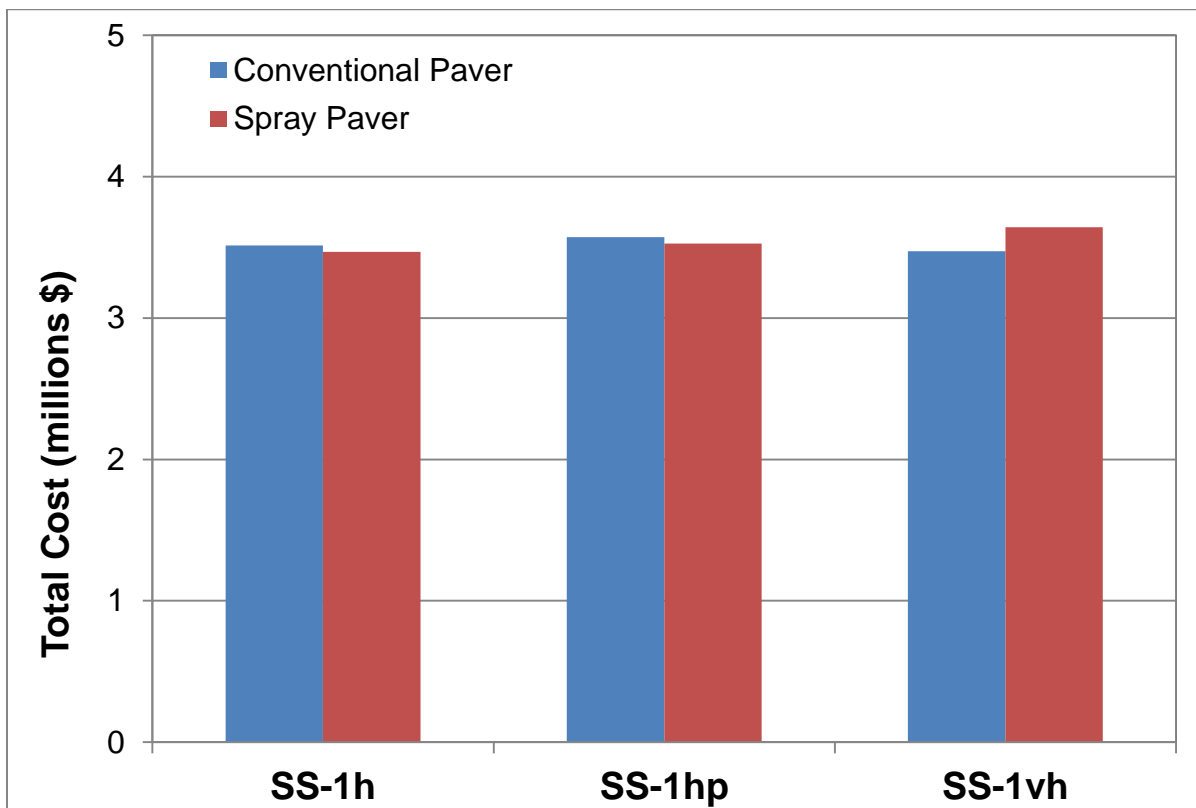
Figure 6.1. Total cost for I-80.

Figures 6.1 and 6.2 present the cost for each project, based on various paving methods and tack coat materials.

As shown in Figure 6.1, there is a small reduction in total cost when the spray paver was used, compared to use of the conventional paver, for SS-1h and SS-1hp tack coats. However, that was not the case when using SS-1vh. The increase in cost when using the spray paver with SS-1vh was due to high cost of the materials. The SS-1vh was found to be the most cost effective material when used with the conventional paver. It will eliminate the cost of the idle time and increase the paving time. This could be significant for contractor, especially when project performance bonuses are considered.

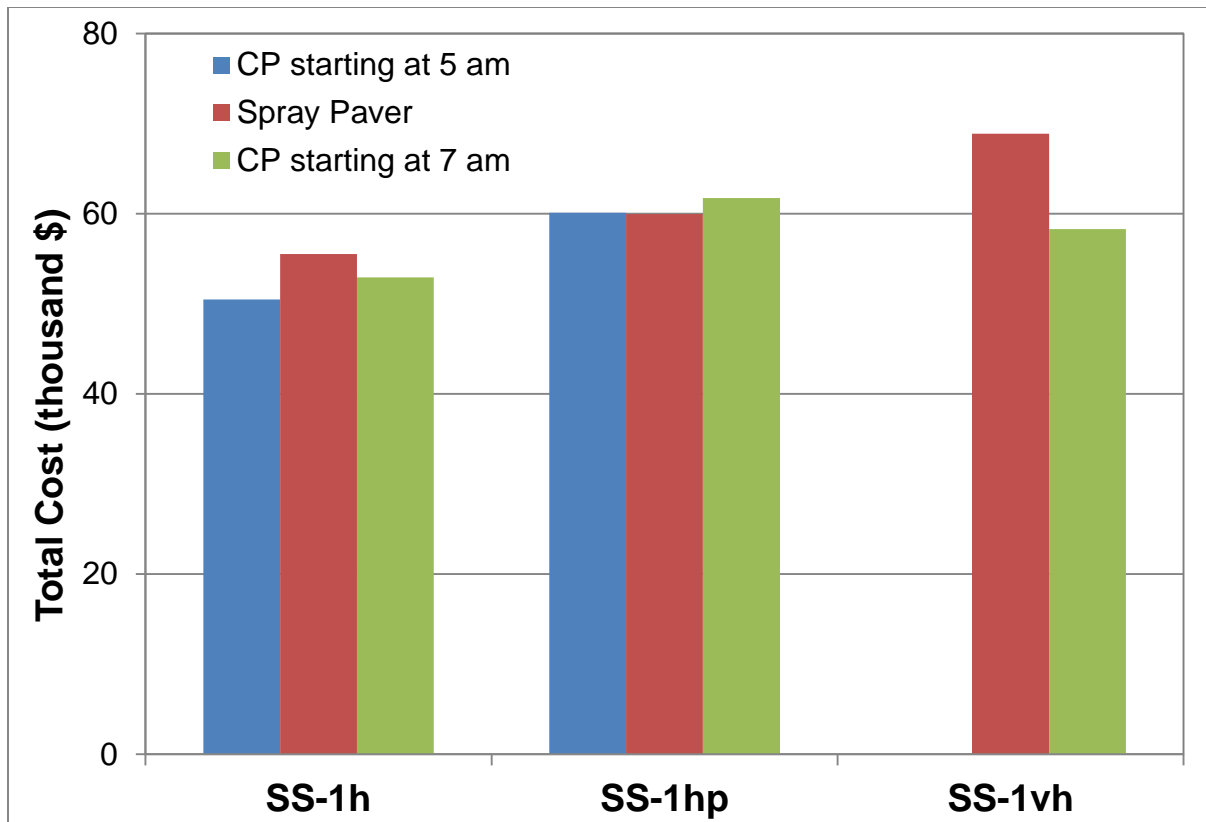
Figure 6.2. Total cost for IL-98.

This trend might be different for various project sizes, as shown in Figure 6.2. In the case of the IL-98 project, the conventional paving method will be more cost effective than the spray paver. SS-1h is the most cost effective when used in small projects. In this analysis, the main factors affecting total cost were tack coat curing time and construction duration. Figures 6.3 through 6.8 show the percentages corresponding to agency and user costs for each analysis per tack coat material. The LCCA performed will help agencies select an optimized alternative method for tack coat application.

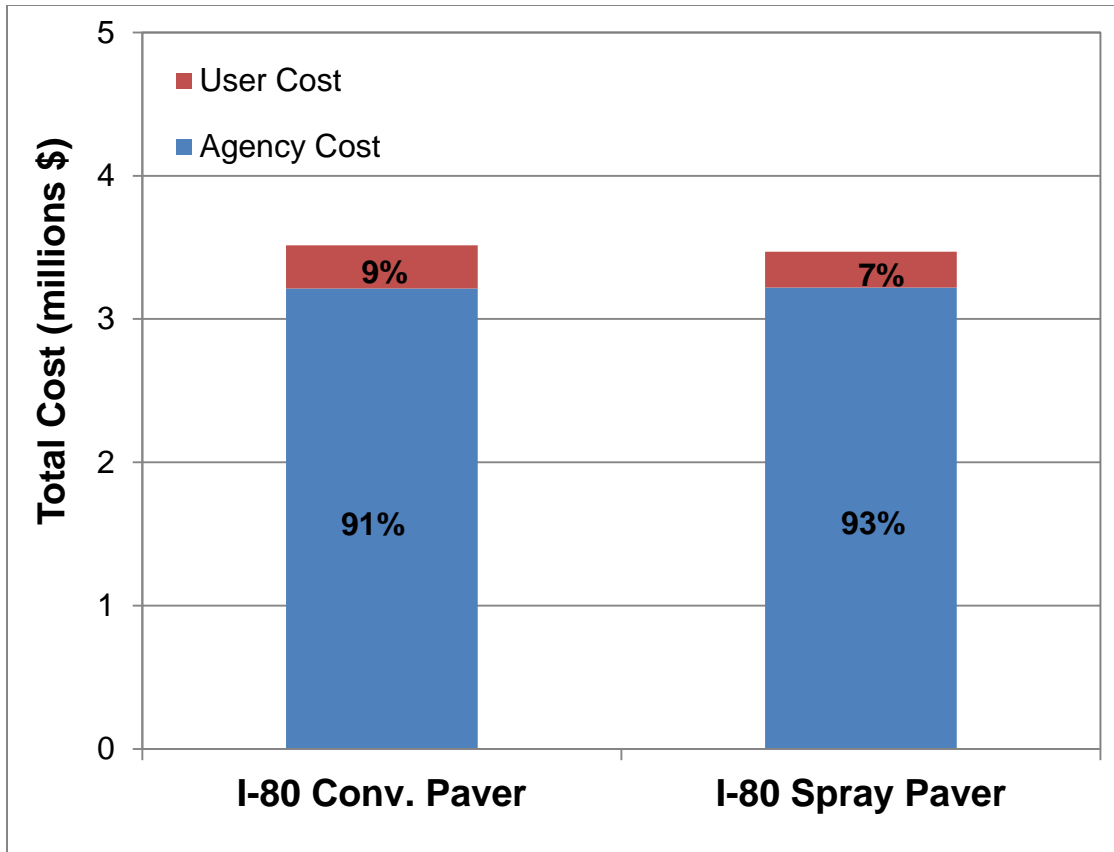
Figure 6.3. Agency and user costs for SS-1h on the I-80 project.

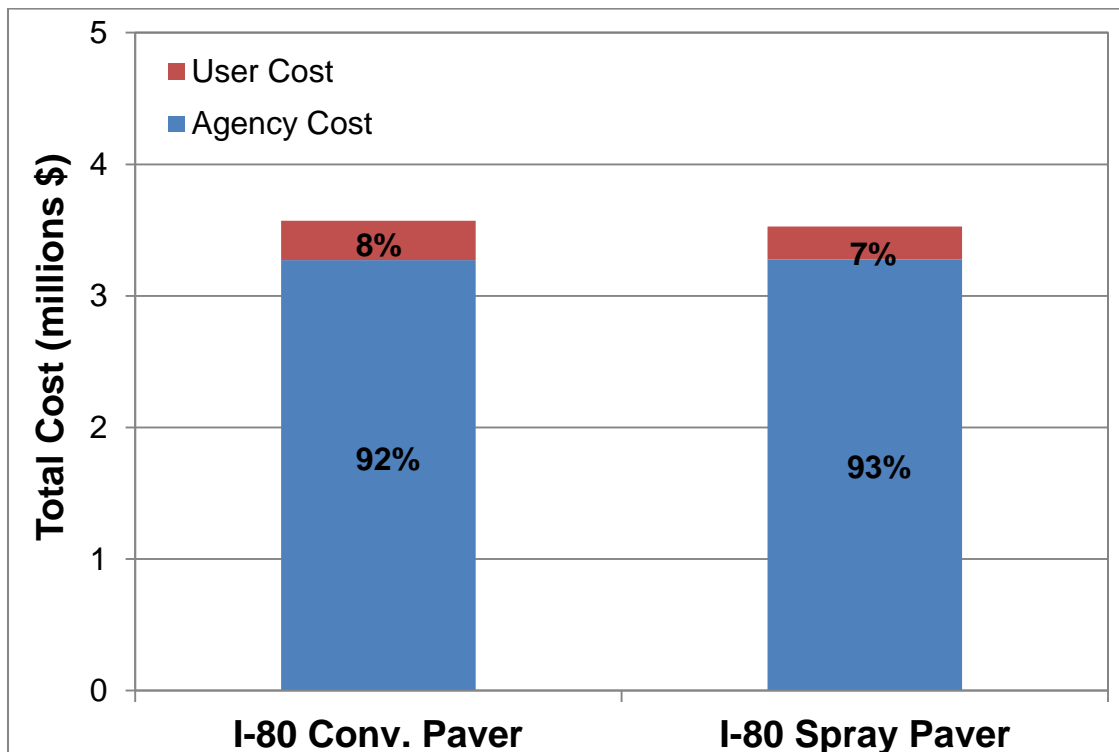
Figure 6.4. Agency and user costs for SS-1hp on the I-80 project.

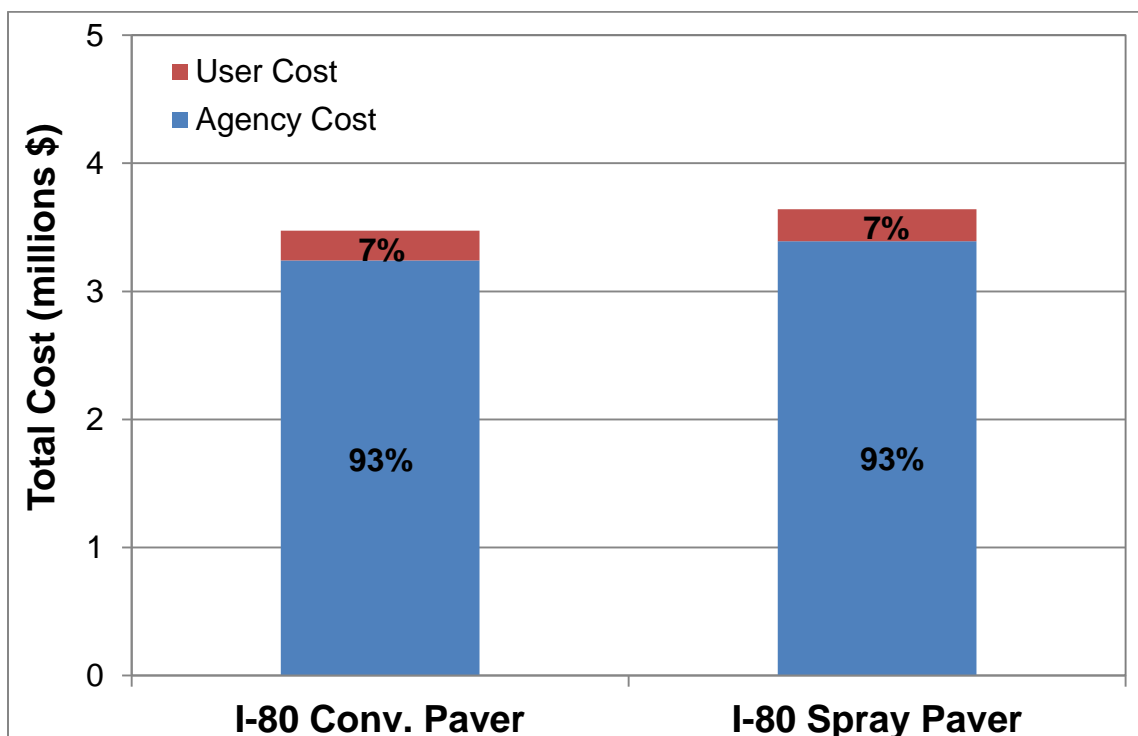
Figure 6.5. Agency and user costs for SS-1vh on the I-80 project.

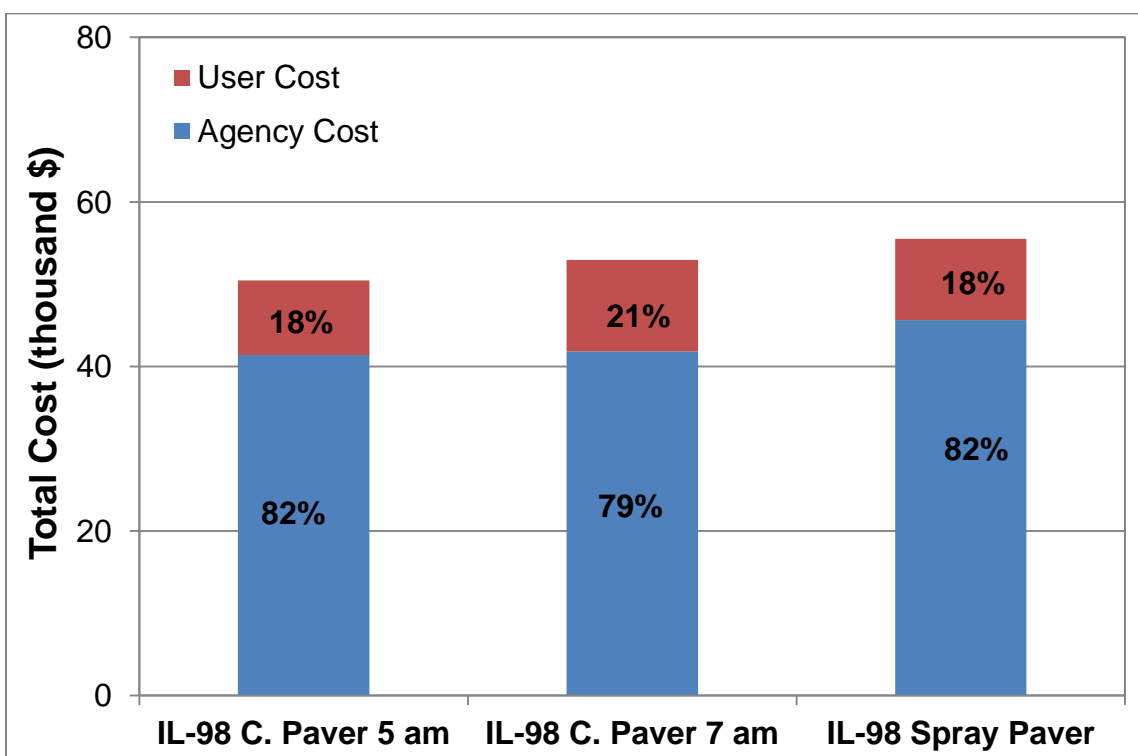
Figure 6.6. Agency and user costs for SS-1h on the IL-98 project.

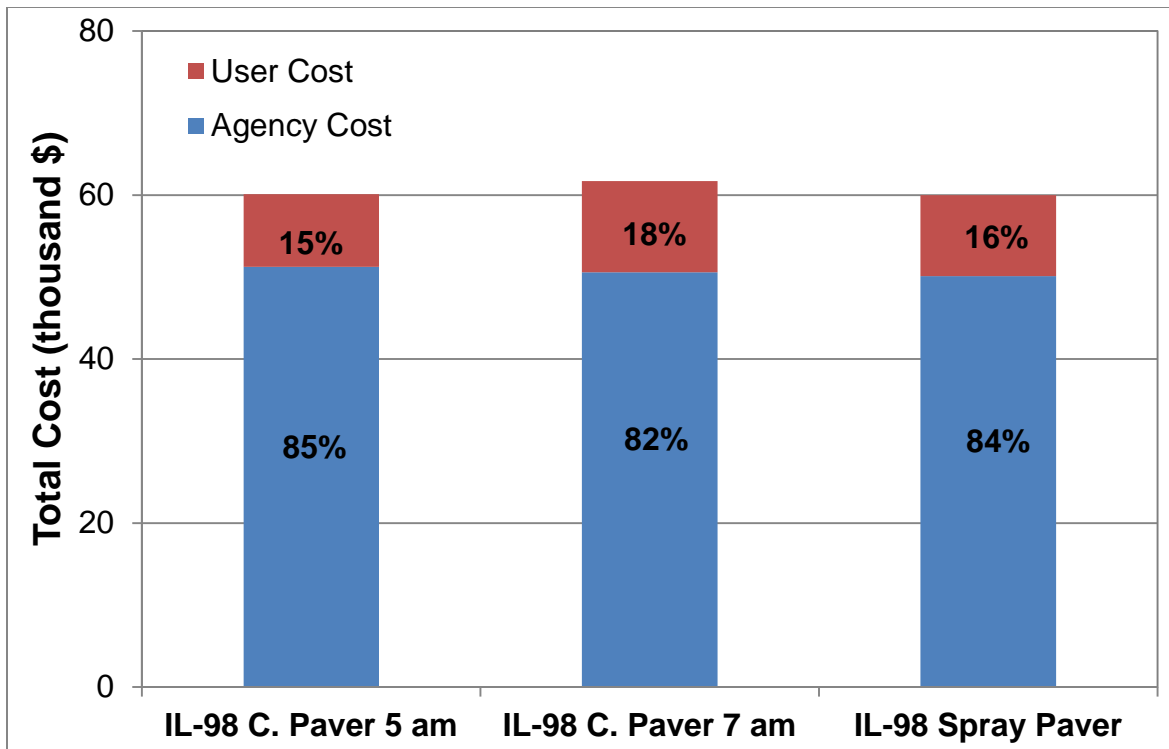
Figure 6.7. Agency and user costs for SS-1hp on the IL-98 project.

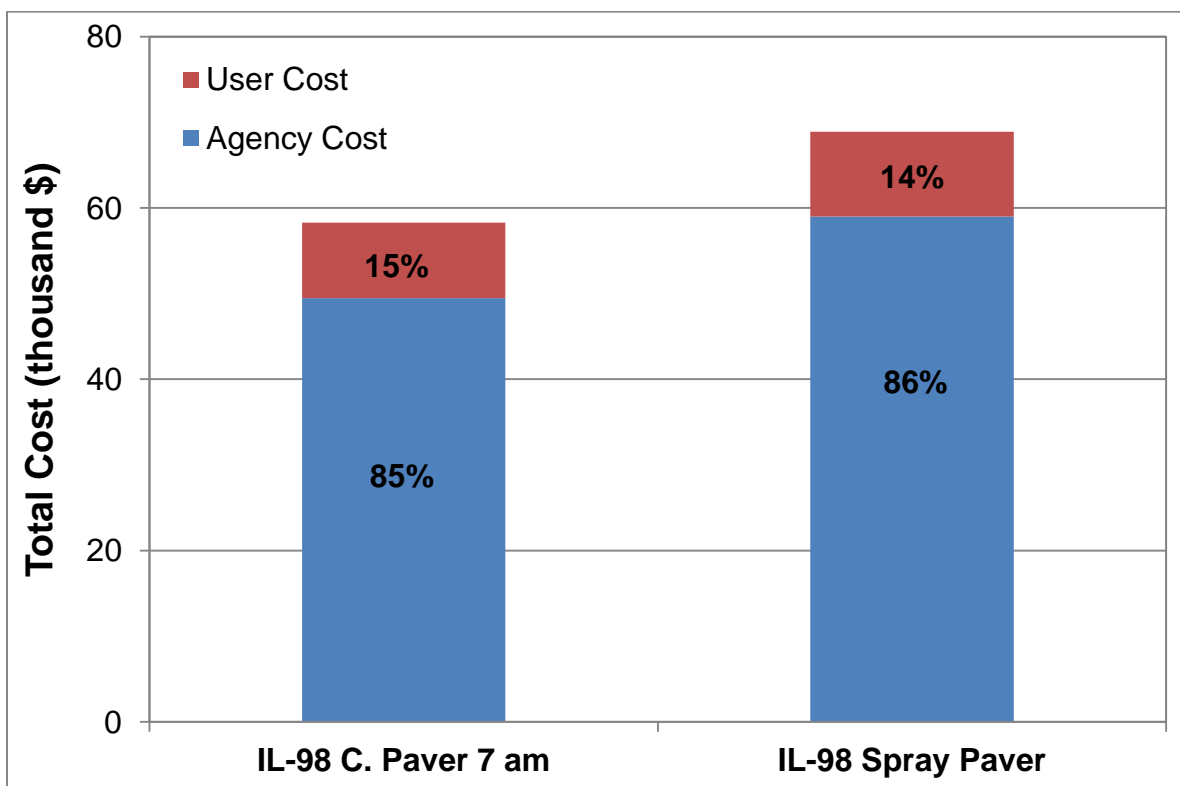
Figure 6.8. Agency and user costs for SS-1vh on the IL-98 project.
